Manhole Inspection Summary

Manhole # S69O__005MH

Insp Date: **2/4/08 2:07 PM**

Location Address: **Steelton Ave.**

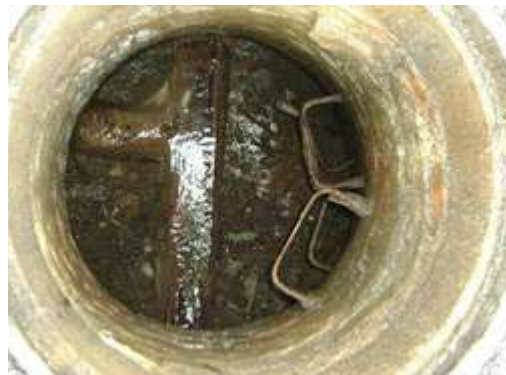
Top View

Type: **Sanitary** Condition: **Sound** Cover Material: **Cast Iron**

Frame Offset: **0** (in.) Condition: ☒ Sound ☐ Cracked ☐ Leaks

Condition: ☒ Sound ☐ Cracked ☐ Root Intrusion ☐ Loose Brick ☐ Deteriorated

Steps Count: **4** Missing: **0** ☒ **Corroded**

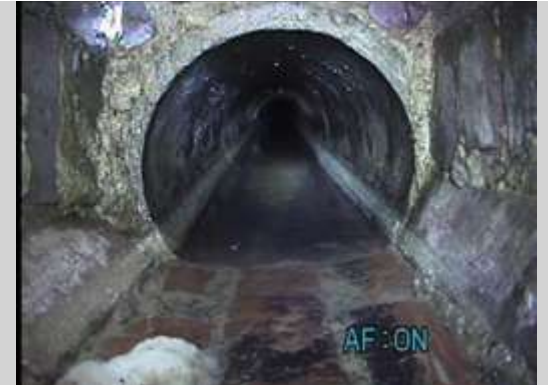
12 O'Clock Outflow

8 in. Circular Gravity Sewer
Pipe Out @ 12 O'Clock

Pipe Height: **8.4** (in.) Rod and Bar (Angled)
Pipe Material: **Clay** ☐ Pipe Lined
Invert Depth: **9.17** (ft.) Flow Characteristics: **Slow**
Deposits: ☒ None ☐ Mud ☐ Gravy ☐ Debris ☐ Grease
Silt Depth: (in.) Deposits Extent:
Infiltration: **None** Pipe Seal Cond: **Sound**

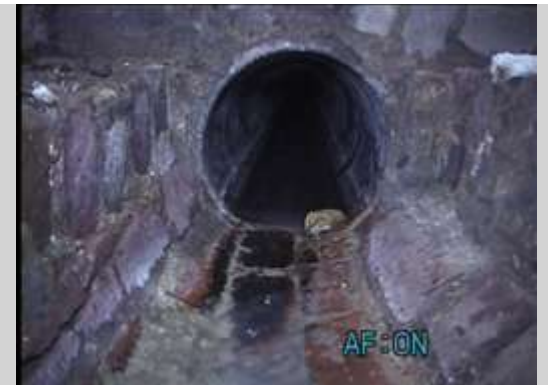
6 O'Clock Inflow

8 in. Circular Gravity Sewer
Pipe In @ 6 O'Clock

Pipe Height: **8.4** (in.) Rod and Bar (Angled)
Pipe Material: **Clay** ☐ Pipe Lined
Invert Depth: **9.08** (ft.) Flow Characteristics: **Slow**
Deposits: ☒ None ☐ Mud ☐ Gravy ☐ Debris ☐ Grease
Silt Depth: (in.) Deposits Extent:
Infiltration: **None** Pipe Seal Cond: **Sound**

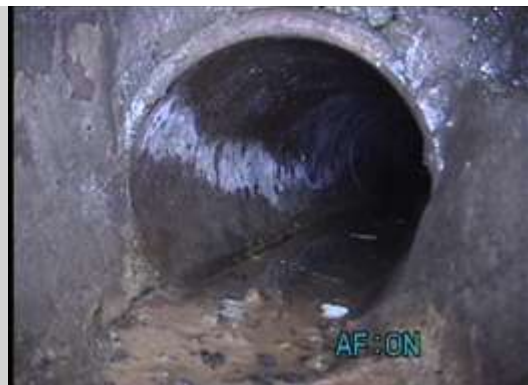
9 O'Clock Inflow

8 in. Circular Gravity Sewer
Pipe In @ 9 O'Clock

Deposits: ☐ None ☐ Mud ☒ **Sludge** ☒ **Debris** ☐ Grease

Silt Depth: **0.25** (in.) Deposits Extent: **Medium**

Connects To: **House connection / Service line**
